MOECKEL DAM
WASHINGTON COUNTY, MISSOURI
MO 30476

PHASE 1 INSPECTION REPORT NATIONAL DAM SAFETY INSPECTION

DECEMBER 1980

SUBJECT: Moeckel Dam Phase I Inspection Report

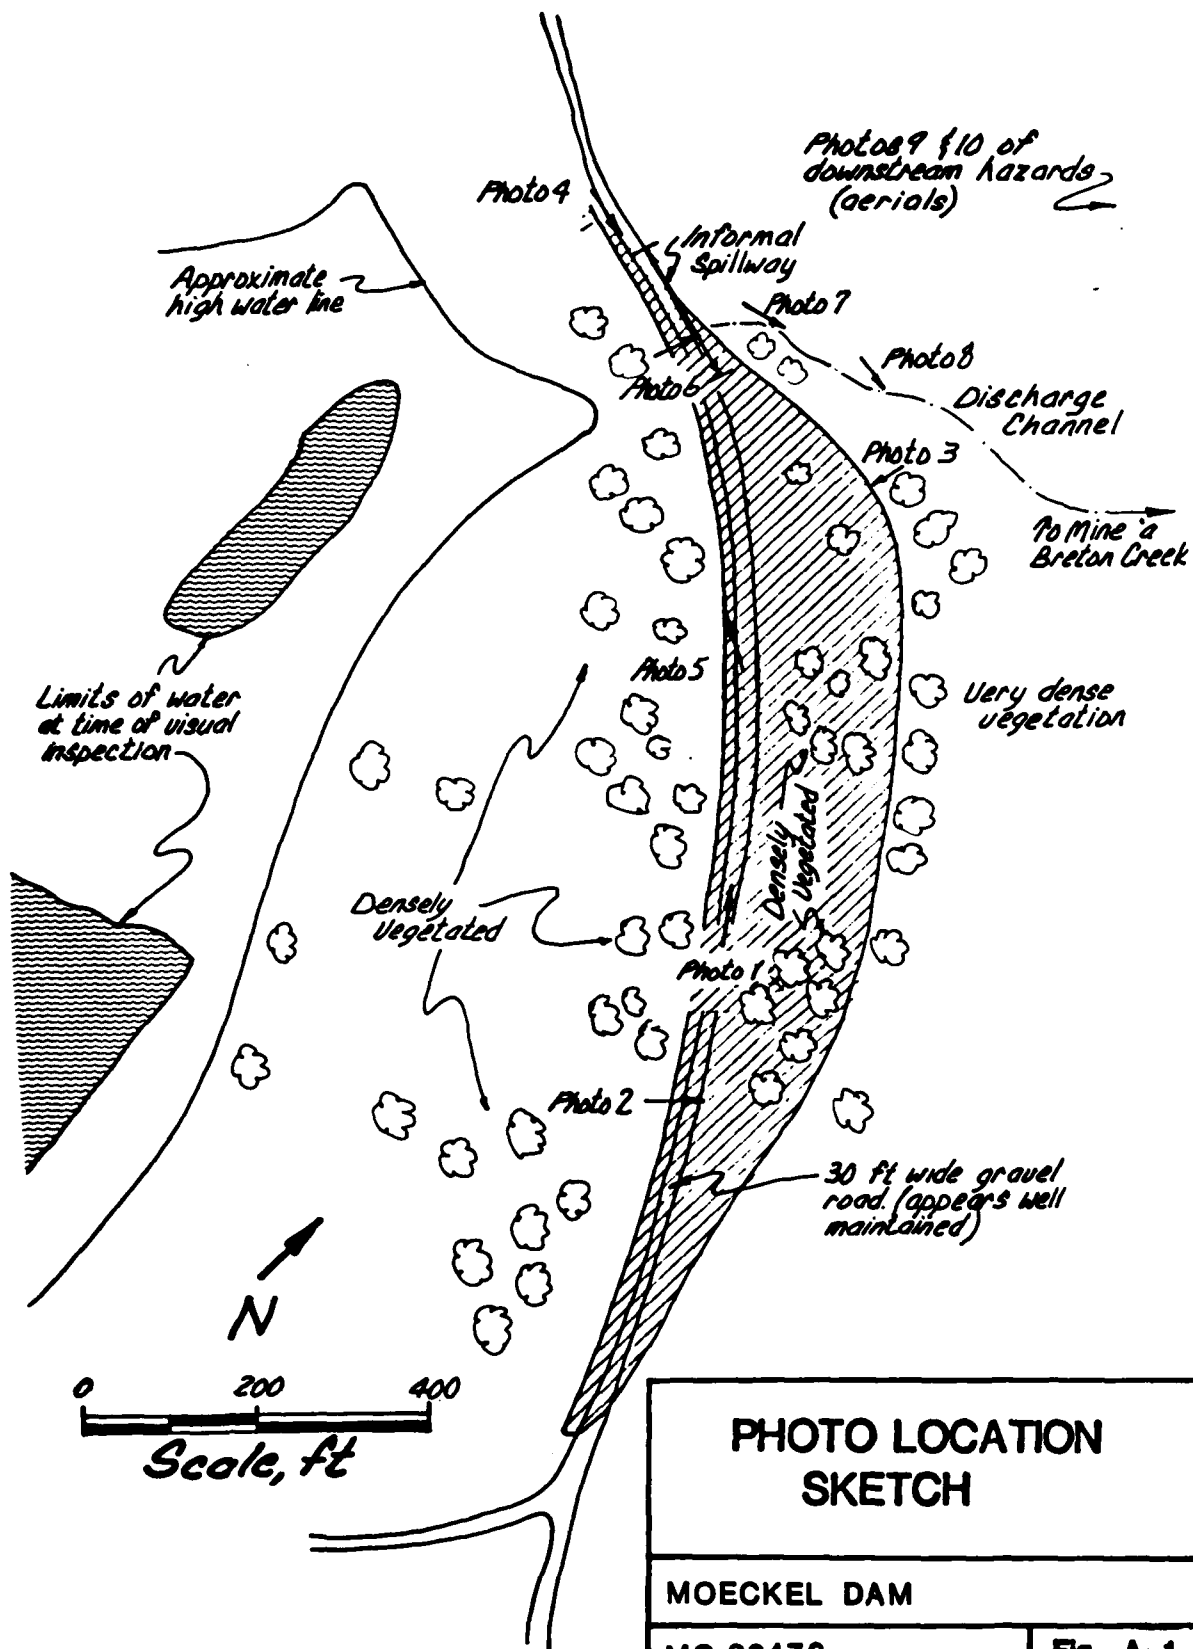
- a. General. The Moeckel Dam was inspected on 16 August, 1980, without the owner's representative present. The results of this visual inspection indicate the dam is in generally poor condition.
- b. Dam. The Moeckel Dam is an abandoned barite tailings dam that borders the impoundment area on the north. A well-maintained gravel road runs along the dam crest (Photo 1) and continues around the impoundment area.

1. Gravel road on crest of dam. Looking northwest. Impoundment to the left.
